REPAIR Good Practice Example: Zejtun, Malta, renovation of historic house

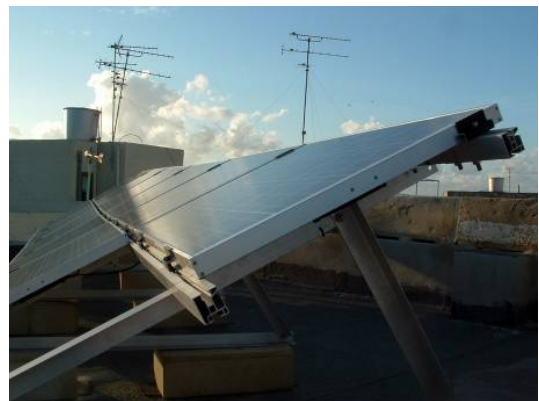
The basic concept behind the project was green restoration. The minimum intervention regime, the use of lime based mortars and 'home-made' lime washes and the use of technology was directed at authenticity and integrity with a focus on energy-efficiency and renewable energy sources.
